Report of Marine Survey

2007 Formula 45 Yacht

“ [REDACTED] ”

Oceanic Yacht Surveys

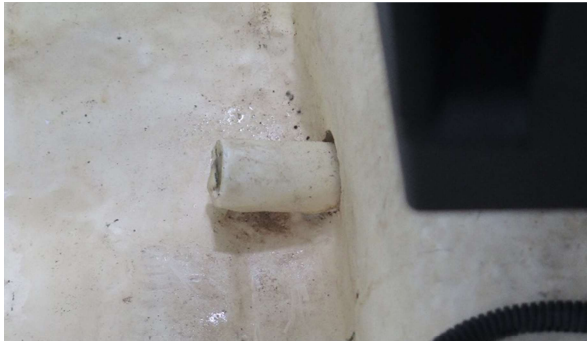
-Bilges are drained through the stingers by limber holes lined with pipe/tubes. The pipe in the limber hole through the outboard starboard engine stringer extends past the edge of the stringer at an upward angle preventing complete drainage from that bilge section **(B1)**.

- B1**, as noted on pages 10 and 11 of the report, the pipe in the limber hole through the outboard starboard engine stringer extends past the edge of the stringer at an upward angle preventing complete drainage from that bilge section. Recommend trimming limber-hole pipe flush with stringer and resealing to stringer.
- B2**, as noted on page 11 of the report, caulking/sealant around the two translucent skylights in deck just ahead of the base of the windscreen is showing some weathering and slight shrinkage in places. Recommend removing old sealant around translucent skylights and resealing with** 3M 4000 Fast Cure UV Sealant.

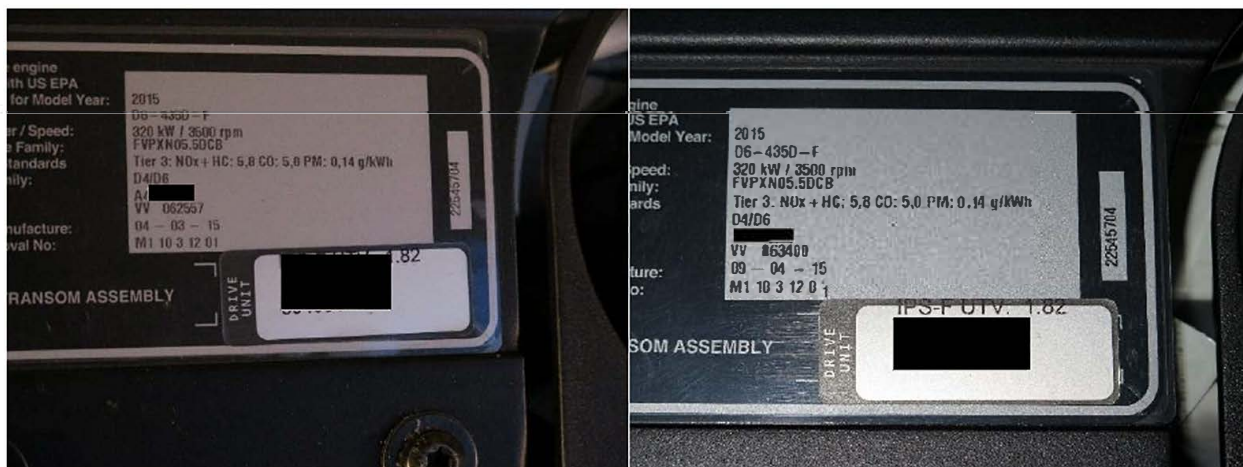
-As shown below, engine serial #'s are, Port: [REDACTED] and Starboard: [REDACTED]. Also note manufacture dates are in 2015. Vessel underwent complete re-power in early 2016 which will carry Volvo warranty on all recently installed Volvo systems (engines, drives, controls and instrumentation) until early 2021. Original engines from 2005 were D6-435-B's, from ships log.

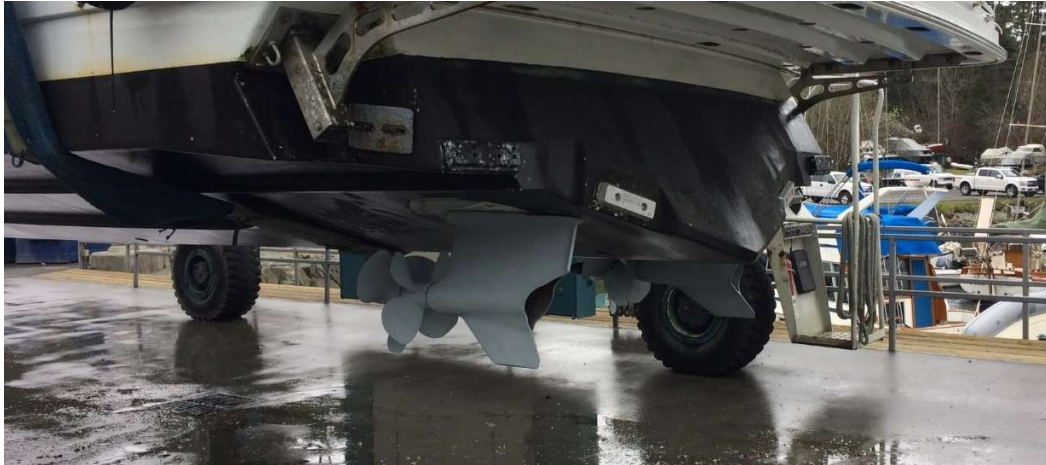
-New (from 2016 re-power) propellers were removed during short lift and replaced with spare propsets that had been cleaned and sprayed with Petit anti-fouling paint.

-‘New’ propellers are serviceable but require cleaning, light sanding and new anti-fouling paint.

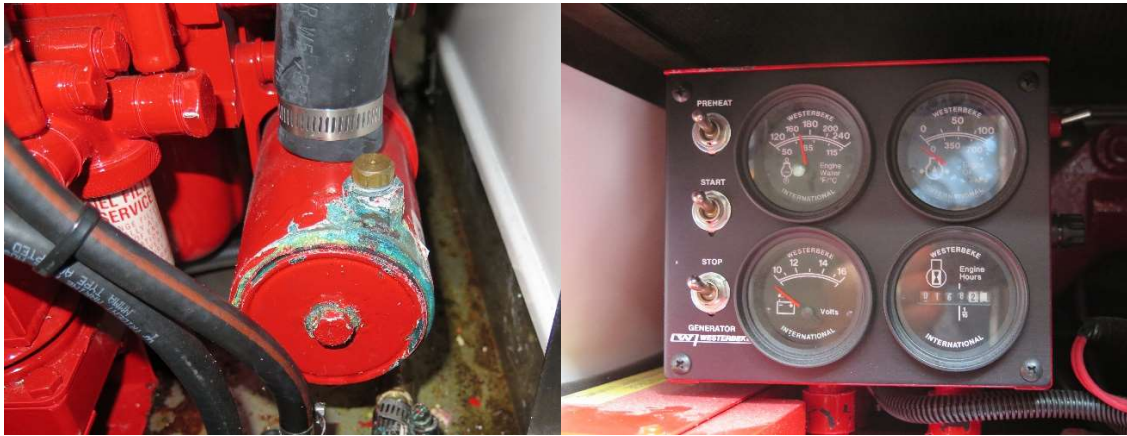
- There is a small amount of external corrosion (see photo above) on the heat exchanger where the finger zinc is inserted (**B3**).
- No oil, coolant or seawater leaks were observed with (B3) as a possible exception.

- B3, clean corrosion from generator's heat exchanger insert plug area and observe for possible seawater leakage. Remove plug and re-seal if deemed necessary.
- C5, non-functioning LED is a convenience item as power supply can be ascertained from voltage gauge directly below LED. Consider having a certified marine electrician repair LED if deemed necessary.

-B3, as noted on page 25 of the report, there is a small amount of external corrosion on the heat exchanger where the finger zinc is inserted. Recommend cleaning corrosion from generator's heat exchanger insert plug area and observe for possible seawater leakage. Remove plug and re-seal if deemed necessary.

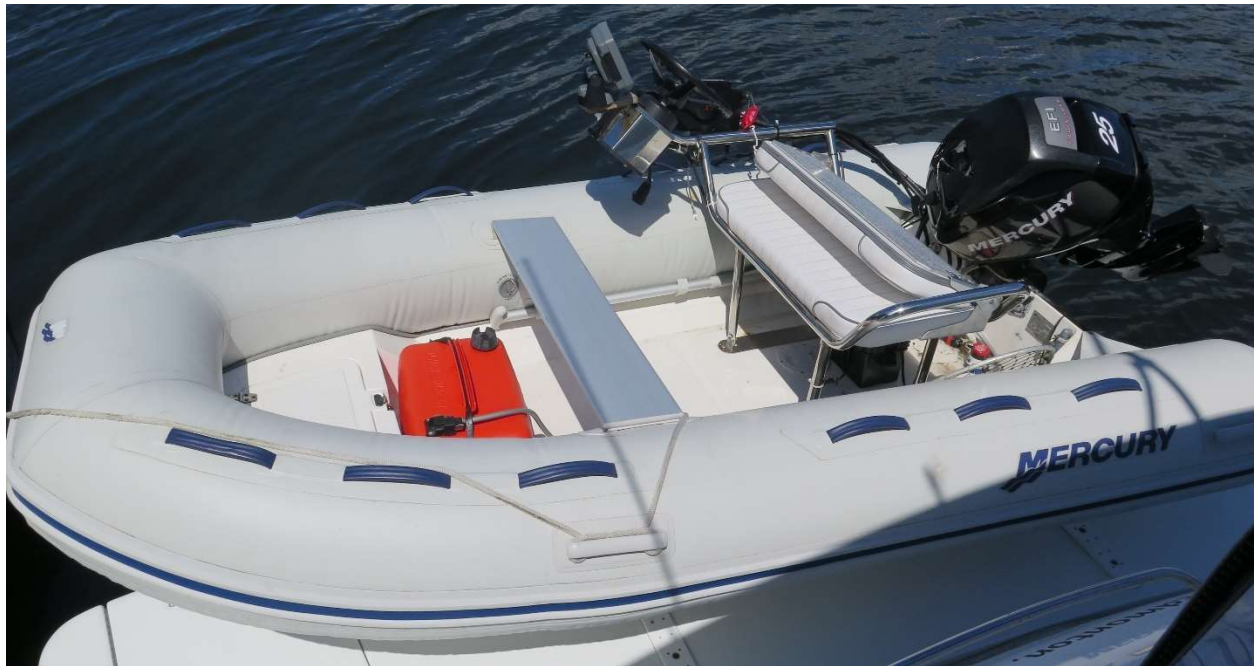
- Tender is not registered (**B4**). Any motorized vessel with 10 Hp or more is required to provincially registered.

-B4, as noted on page 31 of the report, the tender is not registered. Any motorized vessel in Canada with 10 Hp or more is required to provincially registered. Recommend registering tender.
