Report of Marine Survey

2017 Ranger Tug R-27

Oceanic Yacht Surveys Ltd.

The surveyor attended aboard the 2017 Ranger Tug R-27, [REDACTED], at the request [REDACTED], beginning [REDACTED] and finishing on [REDACTED]. The Survey was requested to determine the condition prior to potential purchase, a Pre-Purchase Survey.

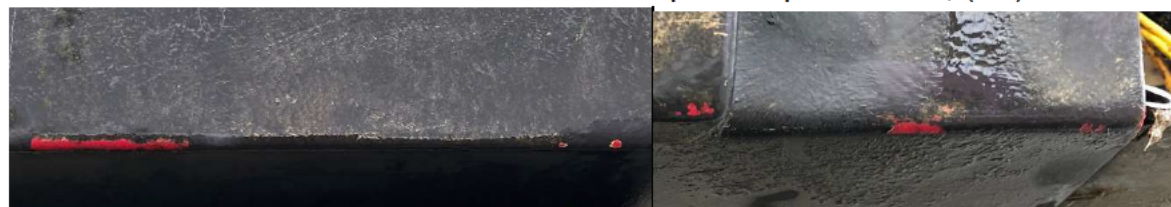
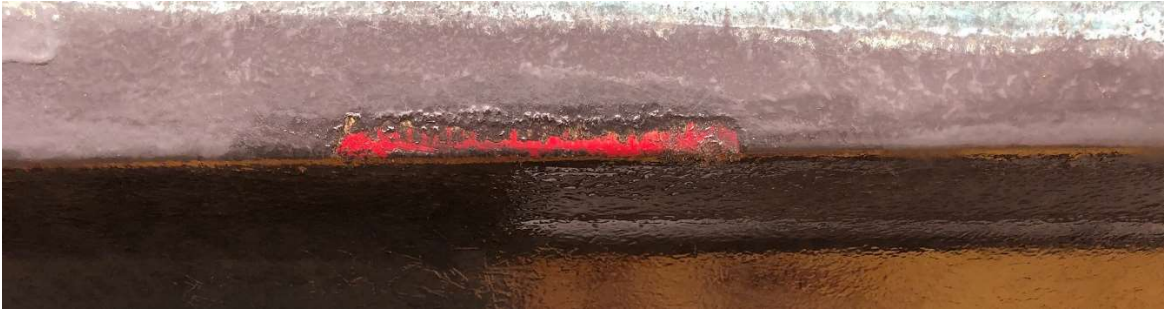
- Vessel was on a trailer for short lift.
- Hull bottom and sides below painted areas were percussion sounded with no irregularities discovered.
- No visible irregularities could be seen.
- Bottom paint is in serviceable condition with a few areas in the outer edge that appear to have been rubbed off of the corner from straps on a previous lift, (C1).

On the port side near the stern (above) and on the starboard side mid-ship (below)

- C1, recommend touching up worn edges on bottom paint next time vessel is lifted.
- C2, recommend checking owner's manual for location(s) of internal anodes on engine components (if any) and confirming if replacement is necessary.

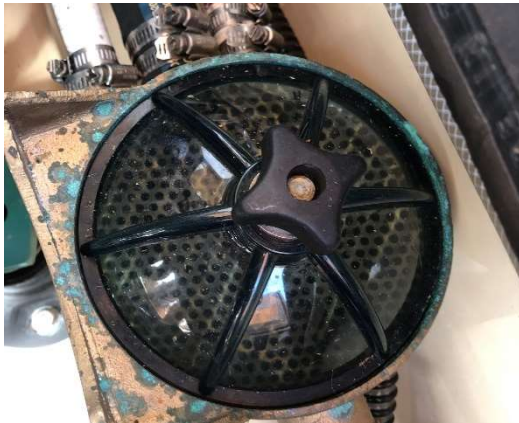
-Water intake strainer was clean and intact with only minor exterior corrosion present. Recommend spraying with silicone or corrosion block spray to prevent further damage, (C3).

- C3, recommend spraying silicone or corrosion block spray on intake water strainer.
- C4, recommend spraying silicone or corrosion block spray on shaft seal nut.

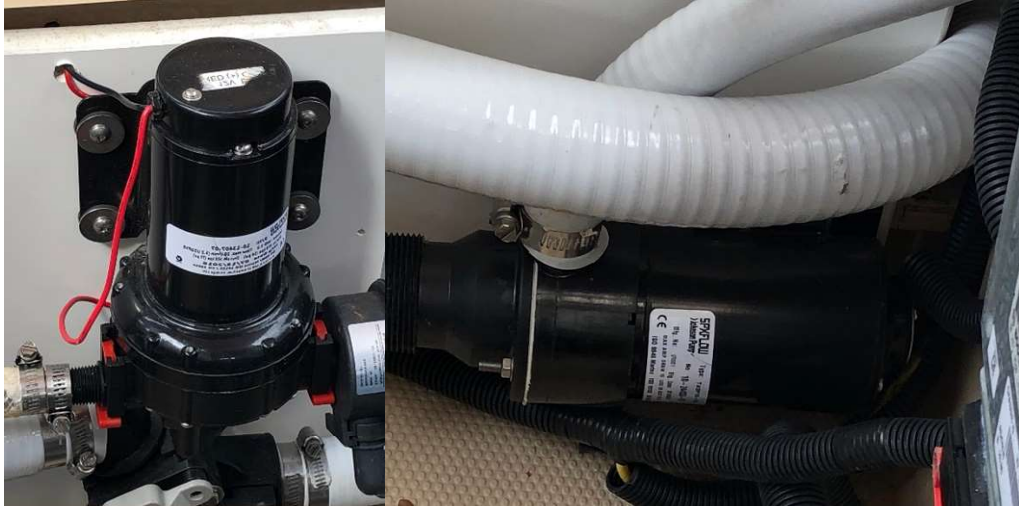
- The top of the 'Y' valve is visible below the raw water pump with the hole for a lock (gray plastic piece at the bottom of the photo below left). When in US waters a padlock is required by law to be placed on the 'Y' valve, locking it closed, (C5).
- The macerator pump is shown in the photo below right.

- C5, recommend having padlock for 'Y' Valve available if voyaging into US waters.

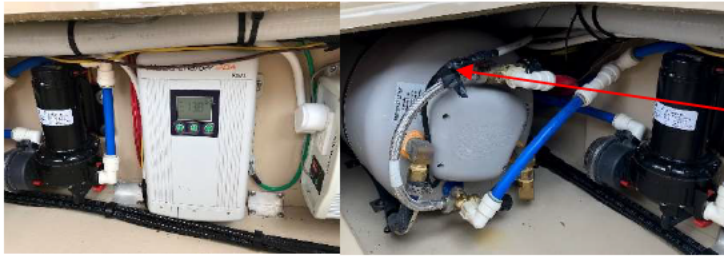
-While the construction techniques used on this vessel almost universally appear acceptable and up to relevant standards, the electrical connection for the water heater power supply is uncharacteristically substandard. Electrical tape is not impervious to water, often loses its stickiness when wet, shrinks and comes loose over time as can be seen in the photo above. The electrical connections beneath the tape were not viewed but should be crimped butt connectors capable of withstanding 30 pounds of tension without separating. The individual crimped connections should be sealed with heat-shrink tubing for corrosion resistance and the entire connection should be contained in larger heat-shrink tubing, not electrical tape, for additional corrosion protection. The wiring should be supported to the hull near the connection to minimize movement, (A2).

A2, recommend removing electrical tape from water heater electrical supply wiring, inspect connection for proper connection installation (as described earlier) and installing and supporting a permanent outer coating. Installation of a proper heat-shrink tubing outer layer, even if the remainder of the connection(s) have been installed to code, will require disassembly of the connection or the supply wiring at the heater. If not familiar with the required procedure, contact qualified personnel to have this done.

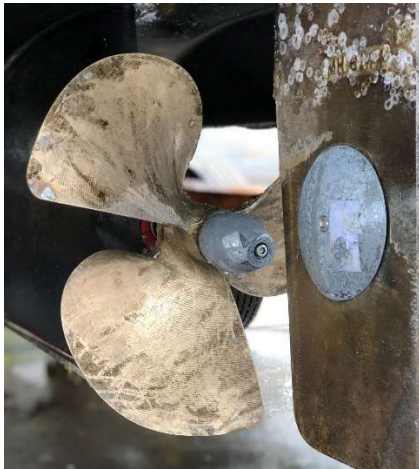
- Propeller is serviceable but required cleaning. Photo is after pressure washing.
- There was no spare propeller found on board.
