Report of Marine Survey

2017 Ranger Tug R-27

Scope of Survey

The surveyor attended aboard the 2017 Ranger Tug R-27, [REDACTED]', at the request [REDACTED] [REDACTED], beginning [REDACTED] and finishing on [REDACTED]. The Survey was requested to determine the condition prior to potential purchase, a Pre-Purchase Survey.

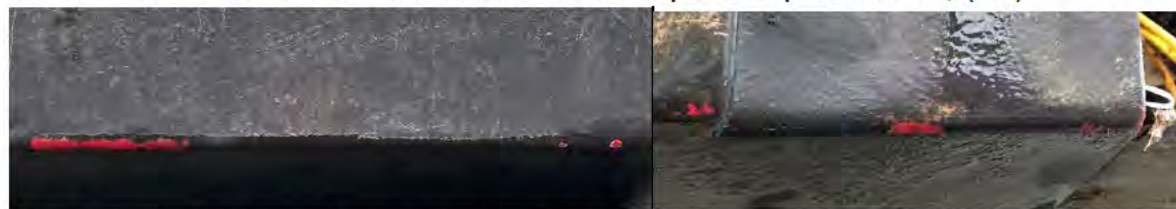
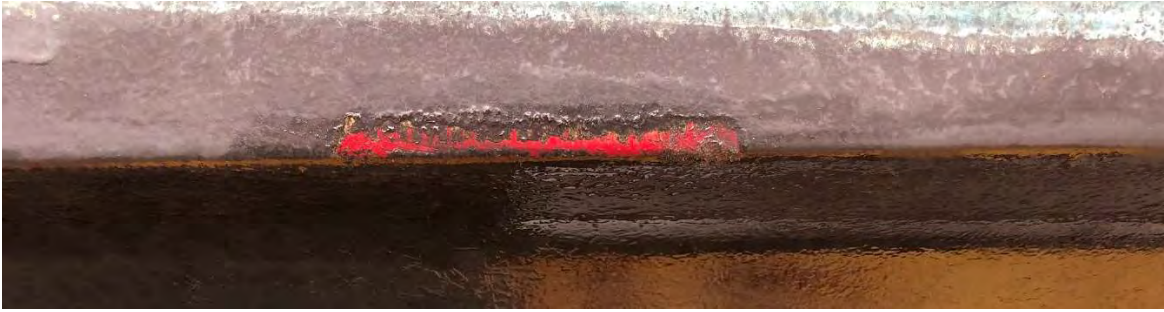
- Vessel was on a trailer for short lift.
- Hull bottom and sides below painted areas were percussion sounded with no irregularities discovered.
- No visible irregularities could be seen.
- Bottom paint is in serviceable condition with a few areas in the outer edge that appear to have been rubbed off of the corner from straps on a previous lift, (C1).

On the port side near the stern (above) and on the starboard side mid-ship (below)

- C1, recommend touching up worn edges on bottom paint next time vessel is lifted.
- C2, recommend checking owner's manual for location(s) of internal anodes on engine components (if any) and confirming if replacement is necessary.

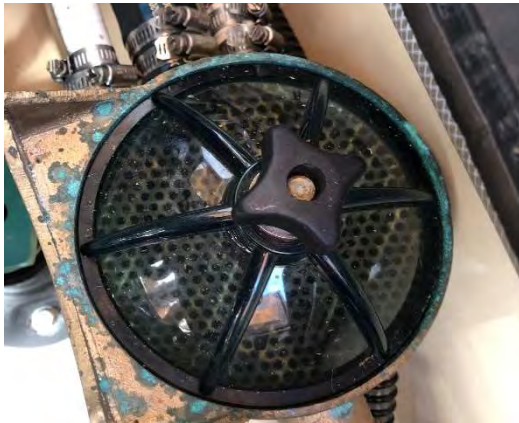
-Water intake strainer was clean and intact with only minor exterior corrosion present. Recommend spraying with silicone or corrosion block spray to prevent further damage, (C3).

- C3, recommend spraying silicone or corrosion block spray on intake water strainer.
- C4, recommend spraying silicone or corrosion block spray on shaft seal nut.

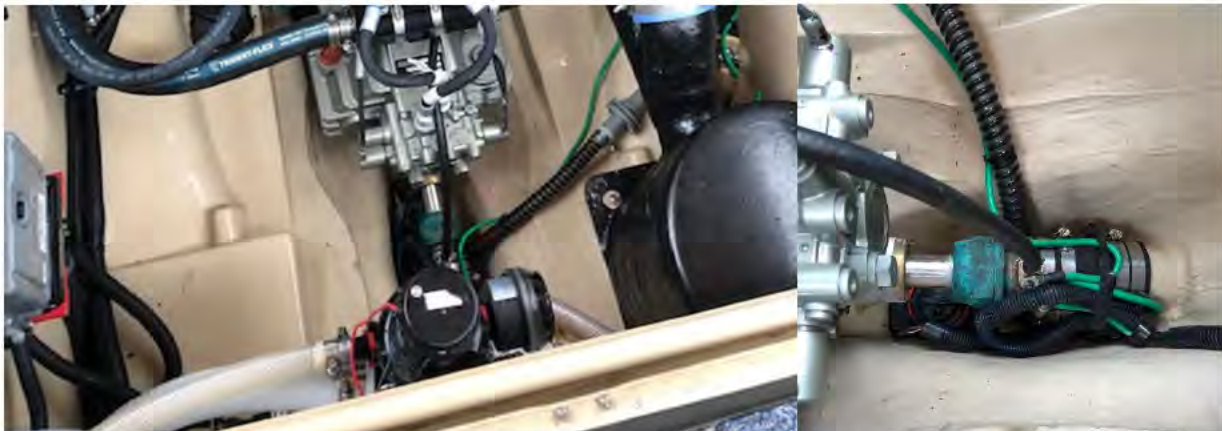
-The engine bilges are spotlessly clean and dry with the exception of a small accumulation of water at the bottom of the keel.

-The dripless shaft seal was observed with the vessel at rest and during operation with no leaks or drips. The seal and adjoining apparatus was felt during operation and was cool to the touch, inferring proper lubrication while running. The shaft seal nut should be sprayed with silicone or another corrosion block spray, (C4).

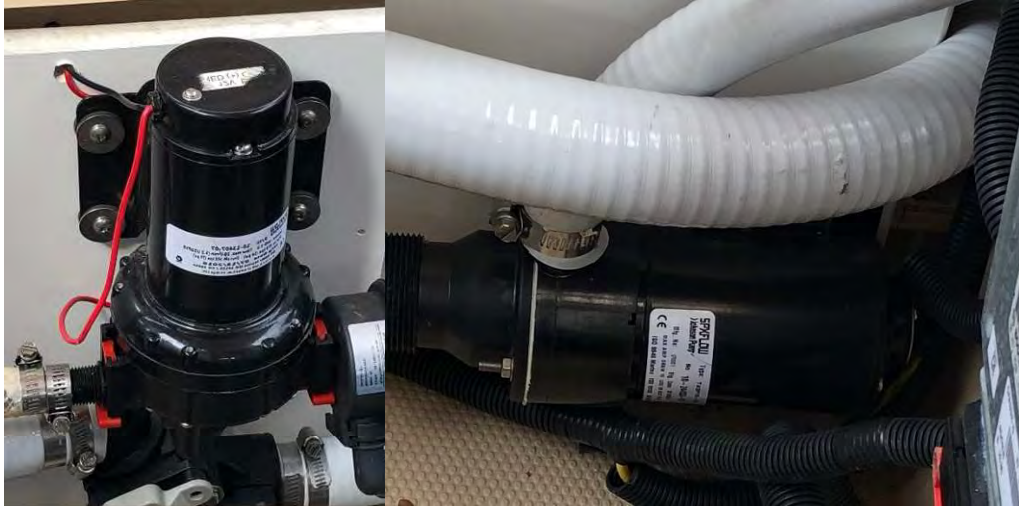
- The top of the 'Y' valve is visible below the raw water pump with the hole for a lock (gray plastic piece at the bottom of the photo below left). When in US waters a padlock is required by law to be placed on the 'Y' valve, locking it closed, (C5).
- The macerator pump is shown in the photo below right.

- C5, recommend having padlock for 'Y' Valve available if voyaging into US waters.

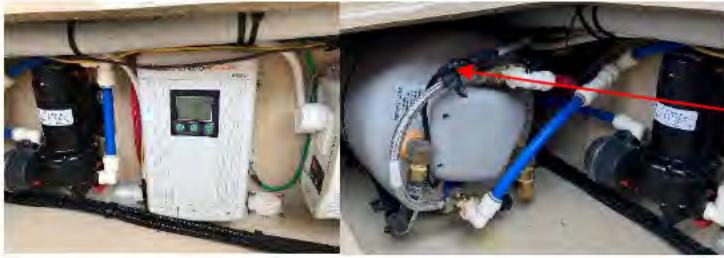
Connections at the ends of wires and splices in the middles are the most frequent points of failure for any wiring, especially in boats. Corrosion, stress, vibrations, and movement are the enemies here as well. ABYC standards are explicit. Also, electrical tape is not acceptable as a permanent wrap.

-All of the above noted equipment was demonstrated and proved to be serviceable.
-While the construction techniques used on this vessel almost universally appear acceptable and up to relevant standards, the electrical connection for the water heater power supply is uncharacteristically substandard. Electrical tape is not impervious to water, often loses its stickiness when wet, shrinks and comes loose over time as can be seen in the photo above. The electrical connections beneath the tape were not viewed but should be crimped butt connectors capable of withstanding 30 pounds of tension without separating. The individual crimped connections should be sealed with heat-shrink tubing for corrosion resistance and the entire connection should be contained in larger heat-shrink tubing, not electrical tape, for additional corrosion protection. The wiring should be supported to the hull near the connection to minimize movement, (A2).

A2, recommend removing electrical tape from water heater electrical supply wiring, inspect connection for proper connection installation (as described earlier) and installing and supporting a permanent outer coating. Installation of a proper heat-shrink tubing outer layer, even if the remainder of the connection(s) have been installed to code, will require disassembly of the connection or the supply wiring at the heater. If not familiar with the required procedure, contact qualified personnel to have this done.

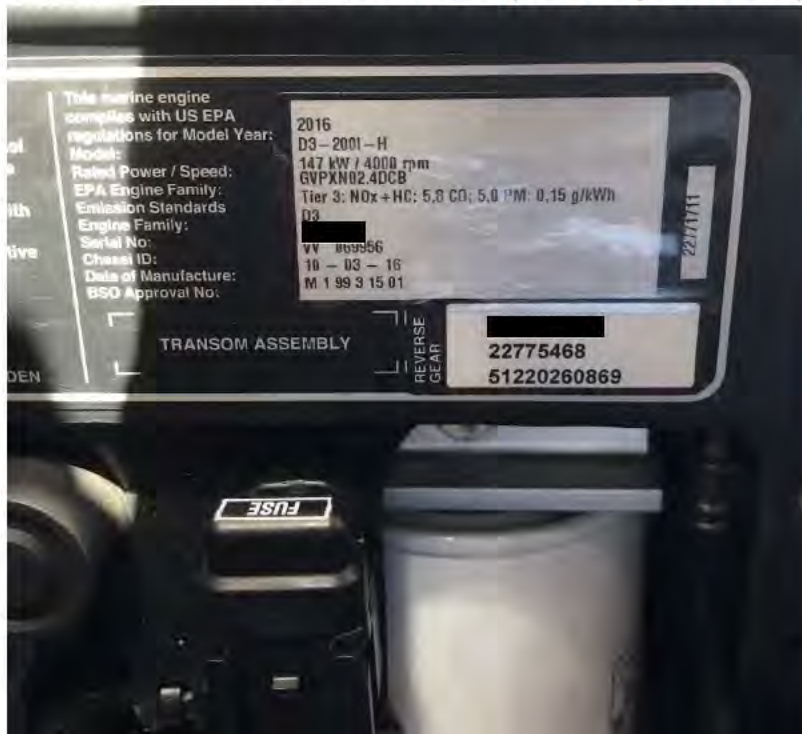
- Single Volvo D3-200-H series inline five cylinder turbocharged and aftercooled 200 Hp (147 Kw) diesel engine.
- As shown below, engine serial # is: [REDACTED]. Also note manufacture date is Oct 3, 2016. Vessel is a 2017 model which would correspond to the factory acquiring the engine late in 2016. This engine should carry Volvo warranty on all installed Volvo systems (engines, drives, controls and instrumentation) for five years from purchase, until early 2022 (C6).

- Steering system operated properly at all speeds from marina to service yard (for trailer lift) and back. Vessel was sea trialed on return trip.
- Confirm remaining Volvo Penta warranty and transferability. Also contact certified Volvo technician to determine if there are any factory recall/warranty items requiring attention.
- The (previous) owner has record of the Volvo recommended 50-hour service completed that includes oil changes in the main engine and transmission (reverse gear, as referred to by Volvo).

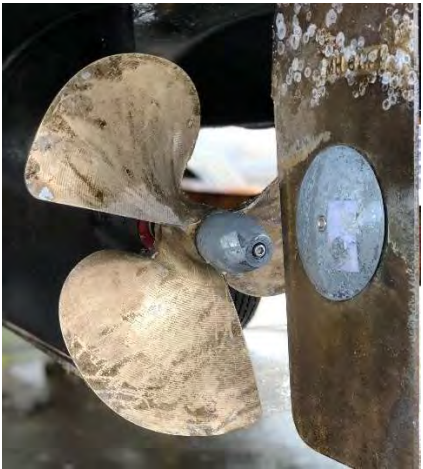
- Propeller is serviceable but required cleaning. Photo is after pressure washing.
- There was no spare propeller found on board.
