Report of Marine Survey

2007 Formula 45 Yacht

“ [REDACTED] ”

Oceanic Yacht Surveys

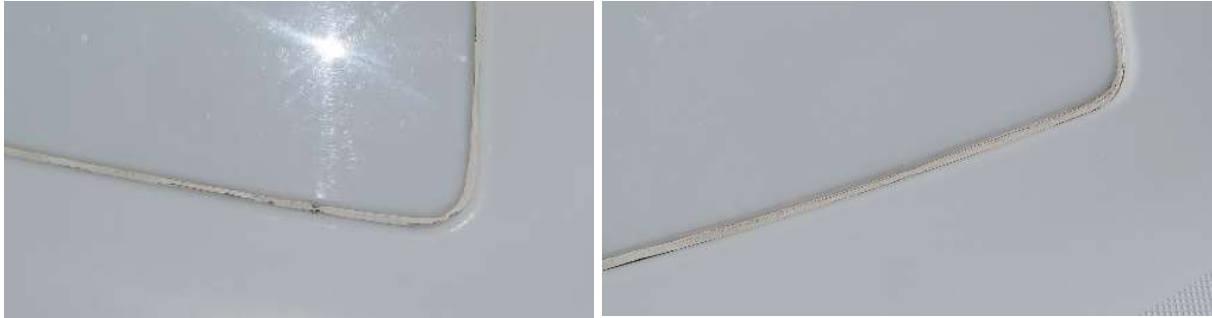
- Stainless steel safety rails with mid-cable run from stern to the bow rail where the mid-cable meets a stainless steel mid-rail. Rails and cables are in serviceable condition.
- Deck was percussive sounded and checked with a moisture meter with no irregularities found.
- (B2), caulking/sealant around the two translucent skylights in deck just ahead of the base of the windscreen is showing some weathering and slight shrinkage in places. As noted, there is no evidence of moisture intrusion in to the deck.

- The vessel has no visible list when at rest in the water.
- As this hull construction reportedly** uses vinylester epoxy resin in the two outer layers, the chance of osmotic blistering would be very rare after 11 years of service. No evidence of blistering was detected and no further investigation using more involved methods is recommended at this time.
- A1, recommend replacing cabin bilge pump float switch.
- A2, recommend replacing forward engine room bilge pump float switch.
- B1, recommend trimming limber-hole pipe flush with stringer and resealing to stringer.
- B2, recommend removing old sealant around translucent skylights and resealing with 3M 4000 Fast Cure UV Sealant**.
- C1, recommend polishing gelcoat at stern of the vessel before significant chalking occurs.

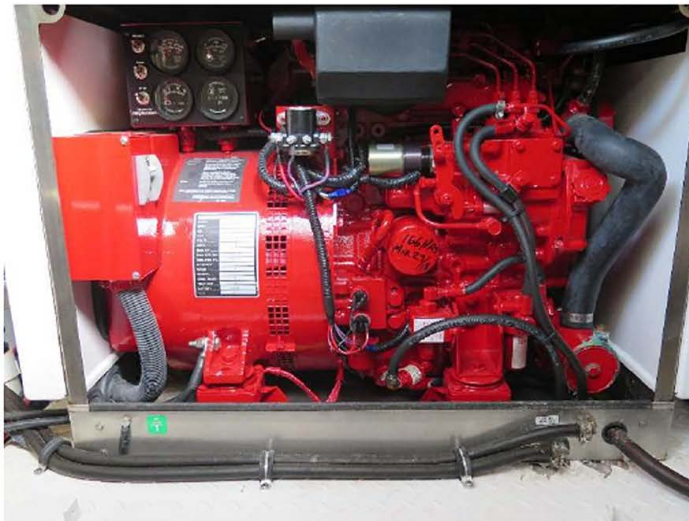
- Westerbeke 12.6BTD three-cylinder diesel powered in sound shield. Serial numbers Engine: [REDACTED] and Generator: [REDACTED]
- Generator instrument panel installed at the generator (showing 168.2 Hrs).
- Oil level was normal on the generator's oil sump dipstick. Writing on filter and ship's log indicate last oil change was at 166 hours
- The coolant header tank's and recovery expansion tank's levels were normal.
- Raw water-cooled exhaust with Primex Silencer plastic composite muffler.
- The generator operated under load from all three HVAC units as required.
- (C5), One LED generator power indicator light is not working. Circuit power can be ascertained from the voltage gauge directly below the faulty LED indicator.
- Specifications include 12.6 Kw, 120/240V, single phase at 1800 RPM, see below.

- B3, clean corrosion from generator's heat exchanger insert plug area and observe for possible seawater leakage. Remove plug and re-seal if deemed necessary.
- C5, non-functioning LED is a convenience item as power supply can be ascertained from voltage gauge directly below LED. Consider having a certified marine electrician repair LED if deemed necessary.
