Report of Marine Survey

2017 Ranger Tug R-27

Oceanic Yacht Surveys Ltd.

The surveyor attended aboard the 2017 Ranger Tug R-27, [REDACTED], at the request [REDACTED], beginning [REDACTED] and finishing on [REDACTED]. The Survey was requested to determine the condition prior to potential purchase, a Pre-Purchase Survey.

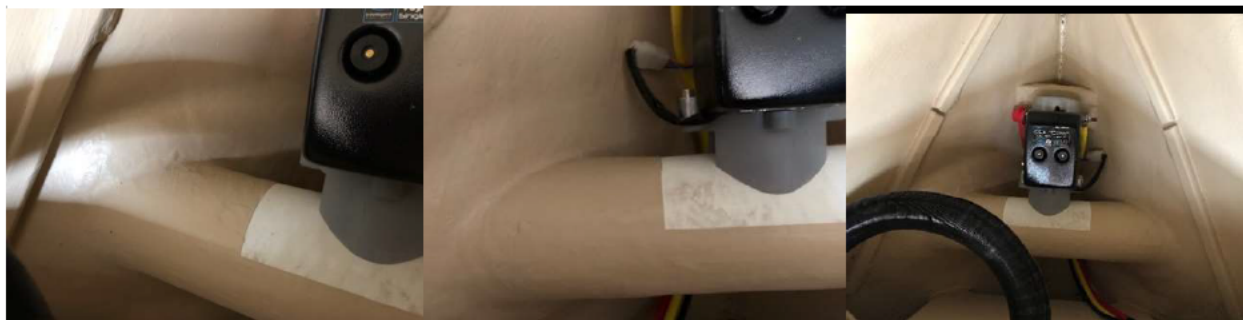
-Bilges were viewed in engine room and forward beneath the lockers in master stateroom.
-Bilges beneath the forward in-floor lockers are spotless and look to have never seen water.
-The forward bow thruster tube can also be viewed here and is also spotless with absolutely no indications of flawed joints to the hull.

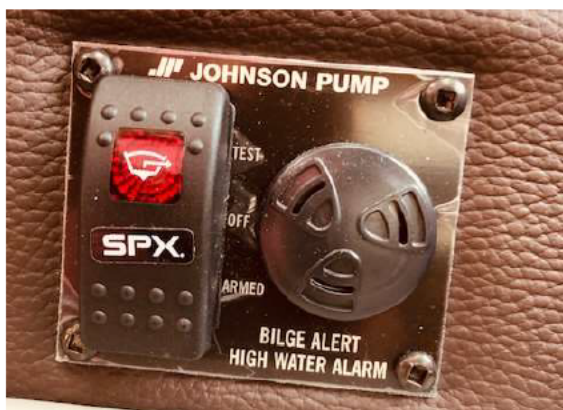
-The bilge pump powered up via the helm switch and the high-water level alarm is functional.

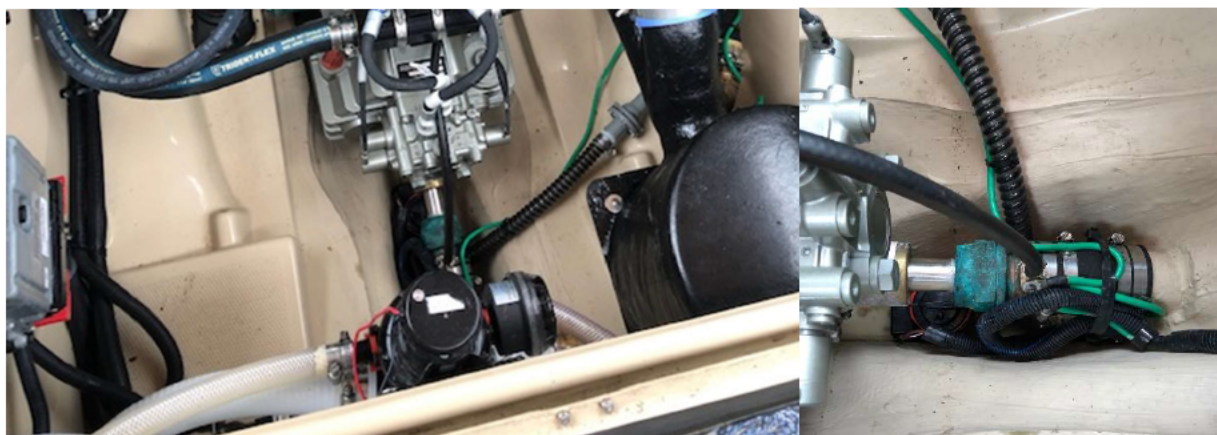
-The engine bilges are spotlessly clean and dry with the exception of a small accumulation of water at the bottom of the keel.

-The dripless shaft seal was observed with the vessel at rest and during operation with no leaks or drips. The seal and adjoining apparatus was felt during operation and was cool to the touch, inferring proper lubrication while running. The shaft seal nut should be sprayed with silicone or another corrosion block spray, (C4).

- C3, recommend spraying silicone or corrosion block spray on intake water strainer.
- C4, recommend spraying silicone or corrosion block spray on shaft seal nut.

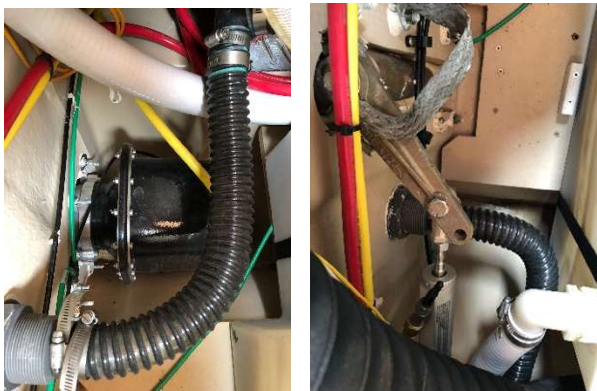
- The aft bilge can be accessed by removing the storage tub beneath the aft bench seat on the aft deck. The tub has drainage into the bilge.
- The aft bilge contains the stern thruster, rudder post and steering actuator.

- The stern thruster mount is intact with no leaks and appears as new.
- The rudder was checked for leakage, none was found, and for play when the vessel was on the service trailer. Play was minimal.
- Rudder actuator was viewed during sea trail and is serviceable.
- Note the grounding strap, green grounding conductors and stainless steel double clamps.

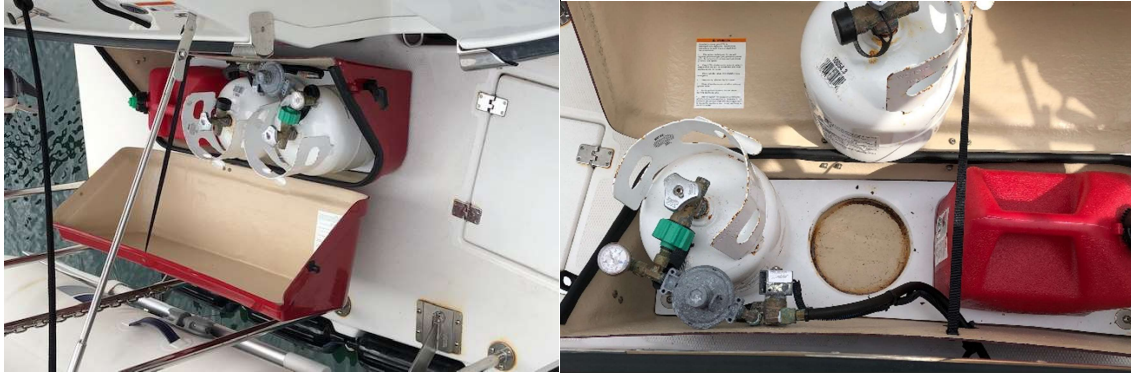
- Fixed white gelcoat finished platform.
- Has three stern fenders permanently attached horizontally across the stern edge**.
- Factory optional stern rails on platform.
- Integral 5 step concealed swim ladder**.
- Propane and tender fuel locker. Propane tanks are to be fixed into place. The base of the locker has a plate with cut-outs to match the base of the propane tank (see above) and when locker lid is closed, the tanks should not be able to move, however, code dictates tanks to be firmly fixed in place. Recommend installing a hold-down bar to hold tanks firmly in place (A1).
- Weaver davit installed for dinghy is removable with locking pins in plates.

- A1, recommend installing hold down bar on propane tanks.
- B1, recommend checking internal anodes, if any, on the engine raw water side of cooling system and replacing if necessary.

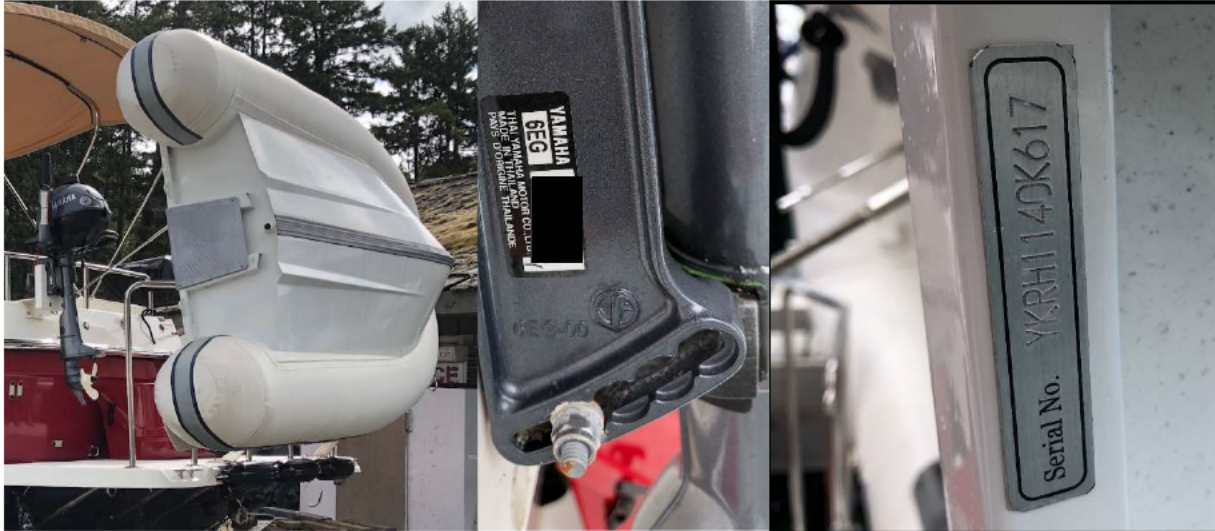
-Yamaha 2.5 Hp, four stroke liquid cooled O/B on stern storage mount appears as new. Engine was not fired but starter cord was pulled to confirm free engine movement and compression. Dinghy and motor serial numbers are shown above.

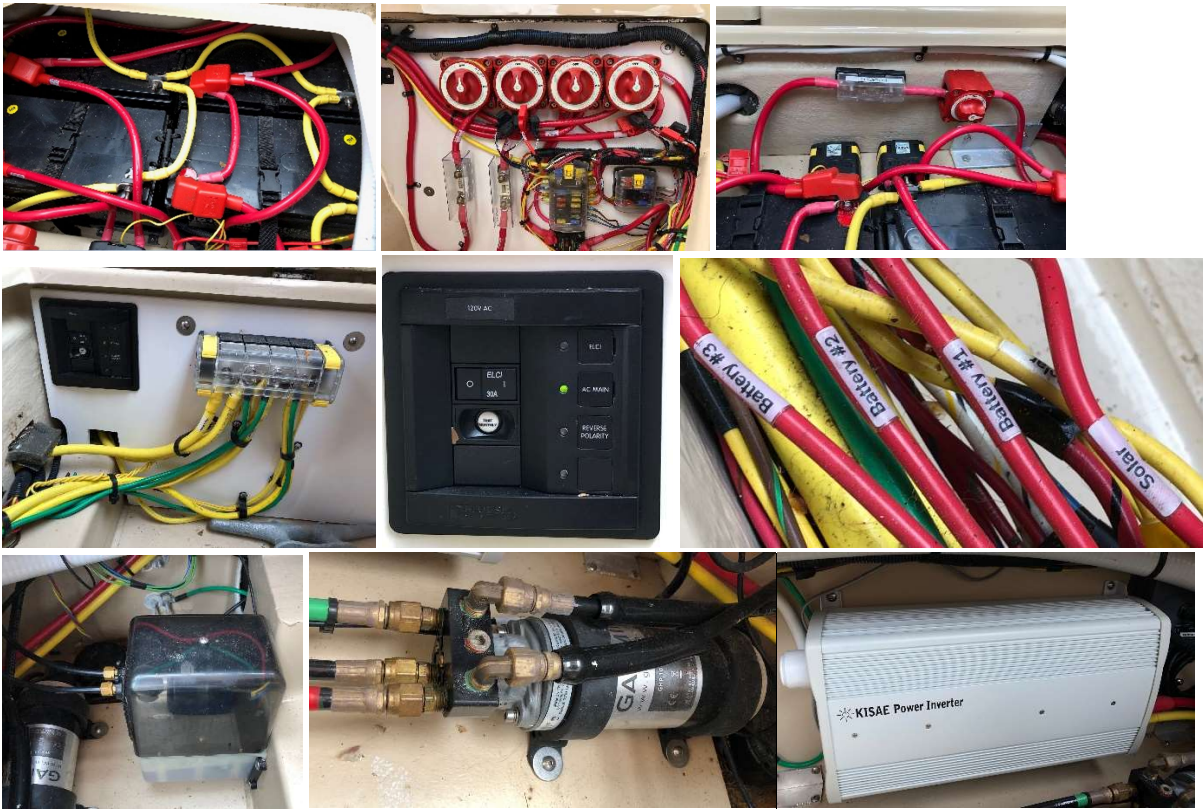
-The aft deck lockers contain numerous system components including the batteries, battery switches, solar panel (shown next page) and inverter interfaces, grounding bus, trim tab hydraulic pump, Garmin auto pilot motor, inverter, charger (shown next page) and water pump and heater (shown next page).

-While the construction techniques used on this vessel almost universally appear acceptable and up to relevant standards, the electrical connection for the water heater power supply is uncharacteristically substandard. Electrical tape is not impervious to water, often loses its stickiness when wet, shrinks and comes loose over time as can be seen in the photo above. The electrical connections beneath the tape were not viewed but should be crimped butt connectors capable of withstanding 30 pounds of tension without separating. The individual crimped connections should be sealed with heat-shrink tubing for corrosion resistance and the entire connection should be contained in larger heat-shrink tubing, not electrical tape, for additional corrosion protection. The wiring should be supported to the hull near the connection to minimize movement, (A2).

A2, recommend removing electrical tape from water heater electrical supply wiring, inspect connection for proper connection installation (as described earlier) and installing and supporting a permanent outer coating. Installation of a proper heat-shrink tubing outer layer, even if the remainder of the connection(s) have been installed to code, will require disassembly of the connection or the supply wiring at the heater. If not familiar with the required procedure, contact qualified personnel to have this done.

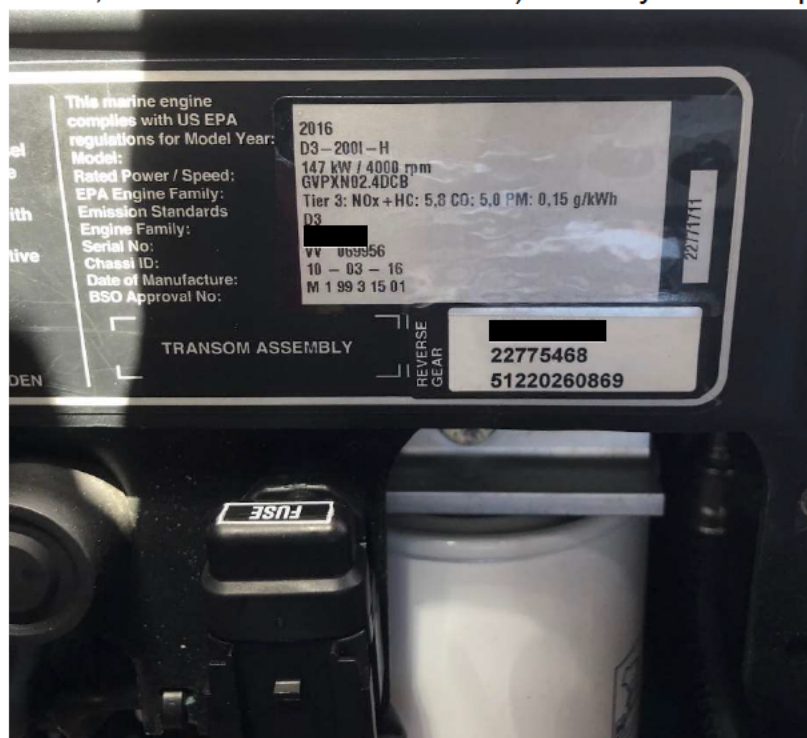
- Single Volvo D3-200-H series inline five cylinder turbocharged and aftercooled 200 Hp (147 Kw) diesel engine.
- As shown below, engine serial # is: [REDACTED]. Also note manufacture date is Oct 3, 2016. Vessel is a 2017 model which would correspond to the factory acquiring the engine late in 2016. This engine should carry Volvo warranty on all installed Volvo systems (engines, drives, controls and instrumentation) for five years from purchase, until early 2022 (C6).

- Steering system operated properly at all speeds from marina to service yard (for trailer lift) and back. Vessel was sea trialed on return trip.
- Confirm remaining Volvo Penta warranty and transferability. Also contact certified Volvo technician to determine if there are any factory recall/warranty items requiring attention.
- The (previous) owner has record of the Volvo recommended 50-hour service completed that includes oil changes in the main engine and transmission (reverse gear, as referred to by Volvo).

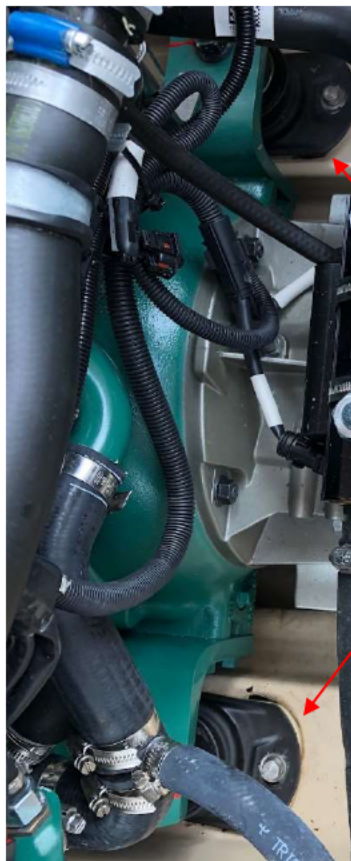
- Engine can be shut down at the helm with the keys and typically directly on the engine with 'Auxiliary Shut Down' button on the engine** (not sighted).
- Engine mounts are serviceable with no apparent wear or observed movement. Aft engine mounts can be viewed as shown in photo below.

The engine mounts on this vessel transfer all of the thrust from the propeller via the propeller shaft through the transmission to the engine to the engine mounts into the hull stringers. For this reason, the condition of the engine mounts is critical.

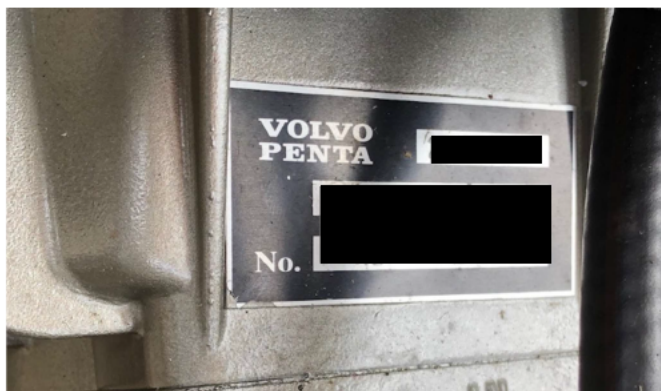
-Transmission is integral with the Volvo drive system and are matched to an engine serial number for warranty purposes. The serial number of the transmission (referred to by Volvo as 'Reverse Gear' as can be seen on the engine ID plate as well as on the transmission. The numbers should match. As can be seen on the photo of the engine ID plate at the top of the previous page, the transmission ID and serial number are: [REDACTED], matching those on the transmission plate as required and shown below (with a 2.034 gear ratio). This is therefore the original transmission installed with this engine.

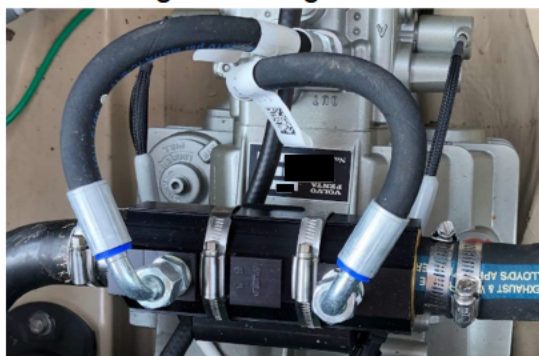
- Based on the information relayed by the (previous) owner regarding the 50-hour service, the transmission oil was changed at that time.
- Oil level was on the dipstick's full mark. Oil was clear and had no unusual odor.
- Oil cooler, mounted on rear of the engine, above the transmission, shows no sign of overheating or leaking.

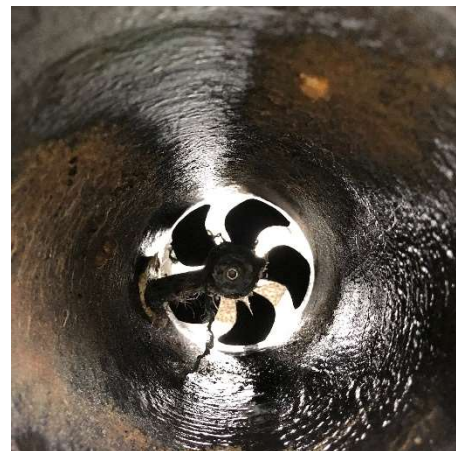
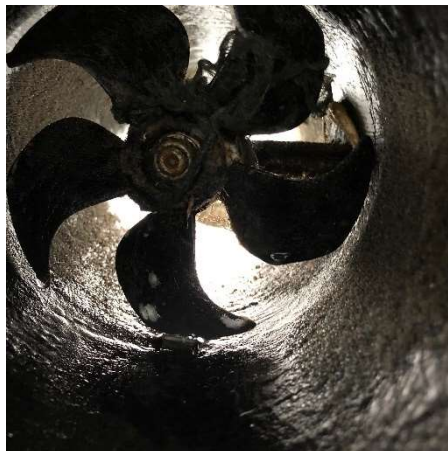
-Bow shown here.

-Thruster tubes and impellers have minor growth but are serviceable.

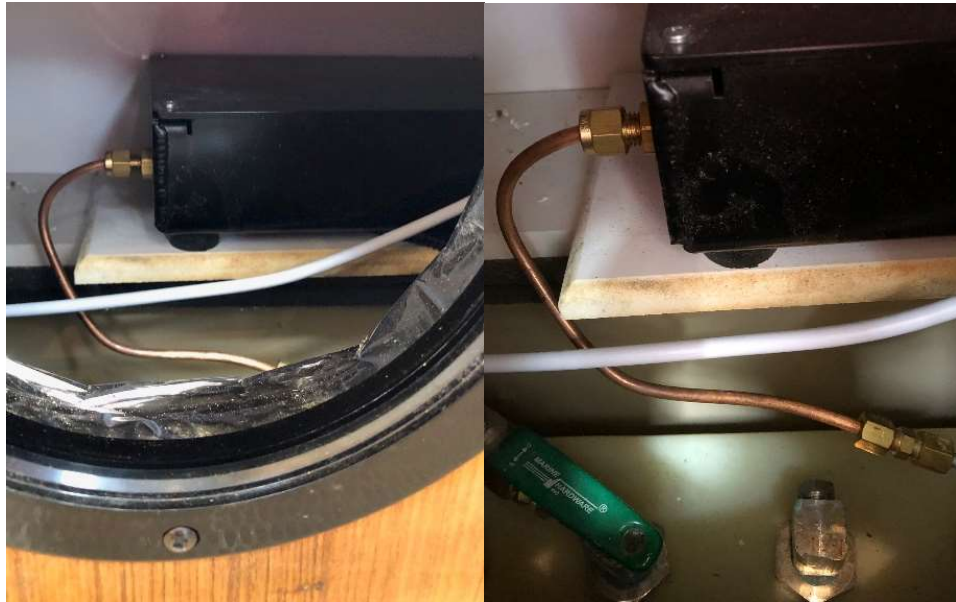
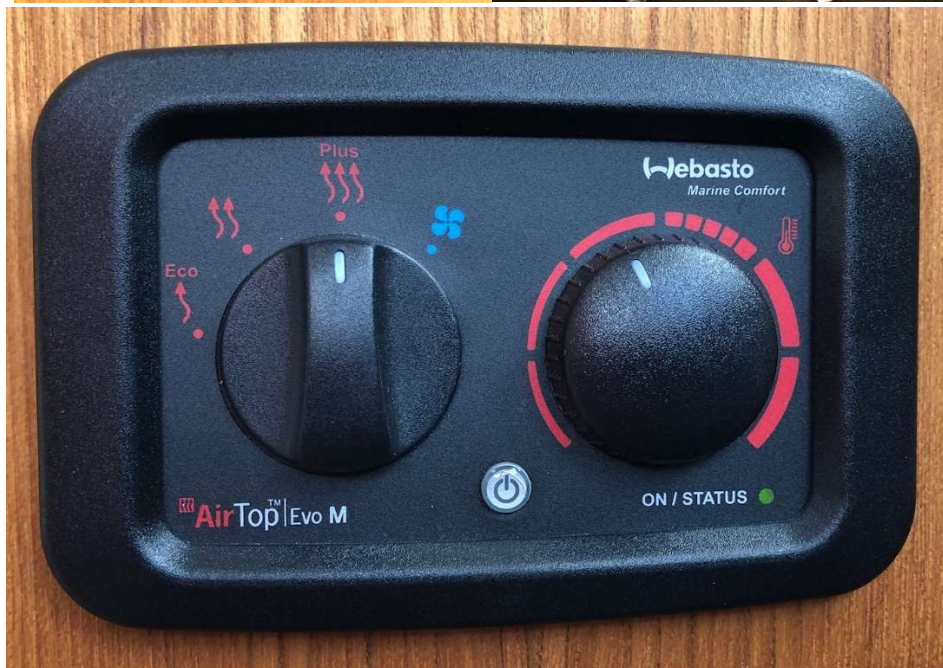
- Main engine and furnace run on diesel from one tank.
- Tank holds 100 US Gallons (approx. 379 litres)**
- Tank is a type of plastic, possibly cross-linked polyethylene but limited viewing access makes identification impossible. Bracing is not viewable.
- Diesel supply pump for Wabasto furnace is viewable in fuel tank inspection port.

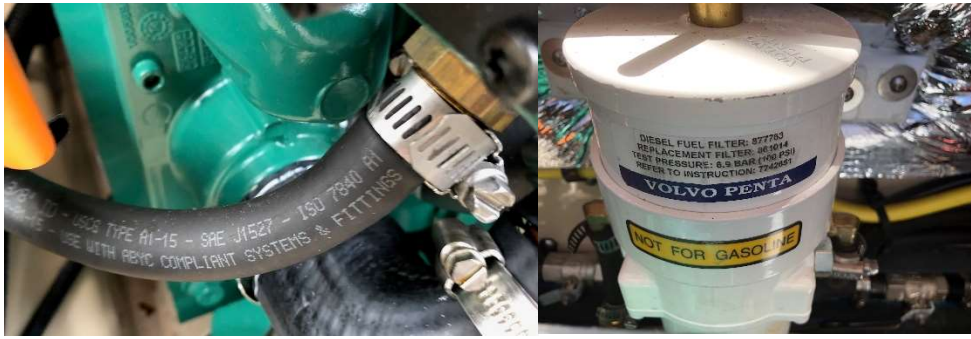
- Fuel fill is located on transom, properly grounded with integral venting.
- Fuel fill hose grade was not viewable. Fuel supply lines are SAE J1527, ISO 7840 A1, USCG Type A1-15 ABYC compliant, shown below.

- Primary fuel filter for main engine is Volvo Penta 877763 fuel/water separator installed with shut-off valves, shown above.
- Main engine has Volvo engine mounted secondary filter and fuel priming button.
- Digital fuel gauge and fuel flow rate data included in the EVC system.

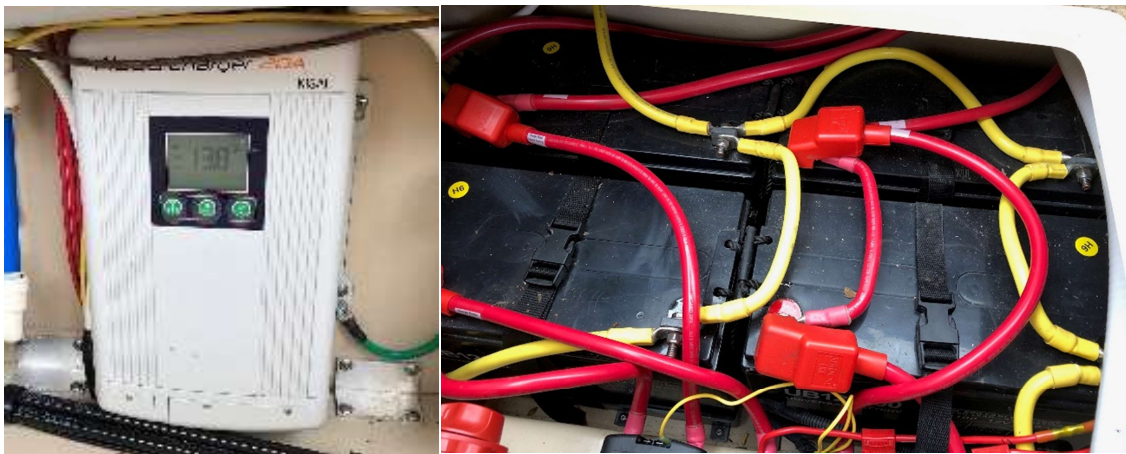
- Ships DC systems are 12V with 12V main engine starting circuits also.
- House batteries are three Universal Battery UB121100 Group 30H AGM (Absorbed Glass Mat) 110 Amp Hour each.
- Main engine starting battery is also a UB 121100 AGM battery.
- There is typically another 12V battery for the windlass but was not sighted. The windlass may be powered from the house batteries.
- Battery charger is 3 bank, 20 Amp Kisae with digital display.

- Charger display indicate proper operation. Display shows batteries at 13.8 Volts.
- Volvo ECV display indicates main engine is equipped with 12V alternator operating properly at +/- 14V.
- 12V wiring appeared to be well supported and secured, where sighted. Chafe gear was sighted at key friction points where viewable.
- 12 Volt outlets at the helm and in the cabin tested at 12.8 volts as did the two downrigger plugs on aft deck.
- The main DC breaker switches were installed in the main panel located at the helm. All breakers and switches were labelled with breaker size and switch function.
- DC is the left side of the panel with AC on the right.
- Toggle switch at top of DC panel section to read voltage from house battery 1, 2 or 3.

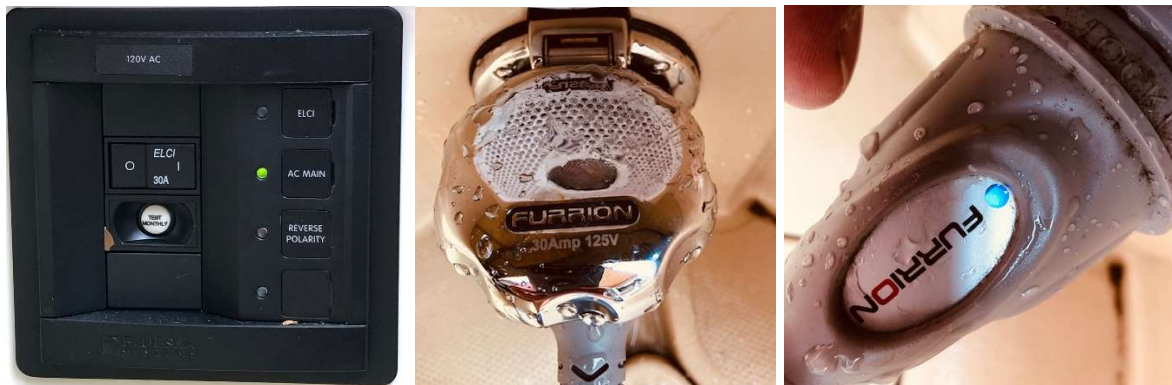
- The main AC breaker is installed in the main electrical panel at the helm with all branch circuit breakers and voltage gauge. All breaker sizes and function are labelled.
- There is a rotary selector switch beside the main panel to turn off and/or select power source between shore power, inverter and generator (not equipped)
- AC outlets were tested using a UL Listed Circuit Tester.
- AC electrical outlet polarity was checked and found to be wired correctly.
- Appeared serviceable for intended use, where sighted.
- Vessel employs Blue Seas Systems, 30A AC ELCI (Electrical Leakage Circuit Interruption) Main Residual Current Circuit Breaker, (leakage trip amperage - 30 mA). ELCI provides overcurrent and leakage protection per ABYC E-11 for whole boat shore power protection.**

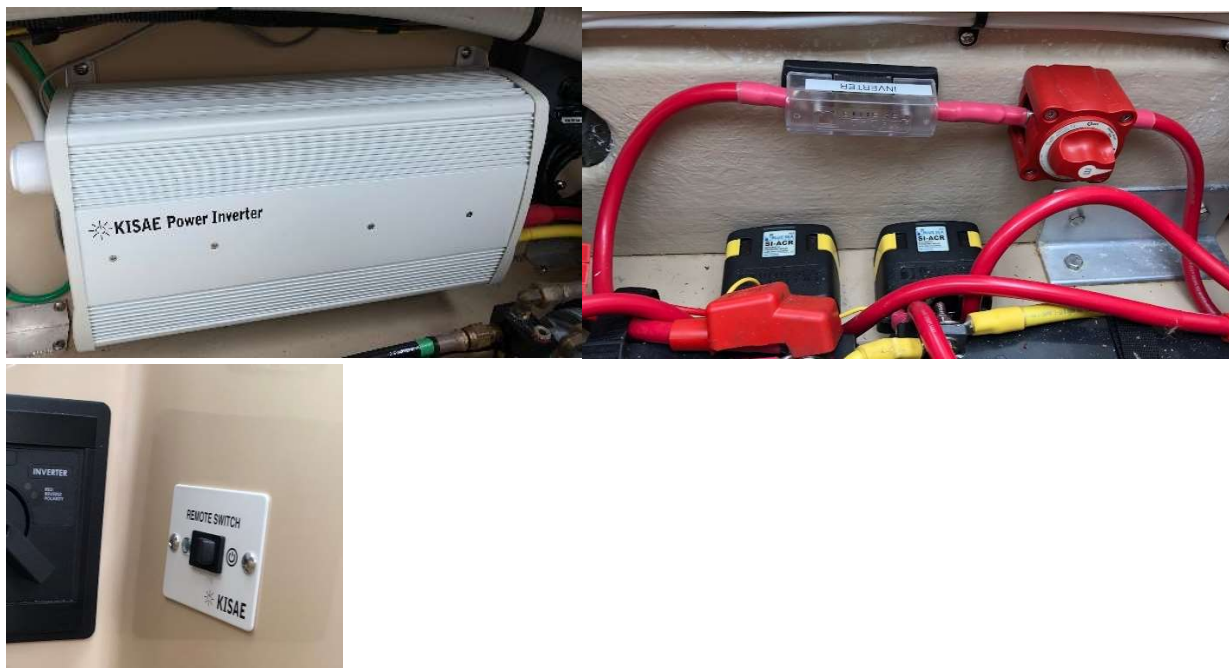
-Kisae SW 1220, true sine wave 2000 watt inverter demonstrated by powering microwave oven. Inverter connections are via rotary switch and inline fuse with activation switch at helm.

None other than **A2**, as previously noted on page 19, systems demonstrated as new.

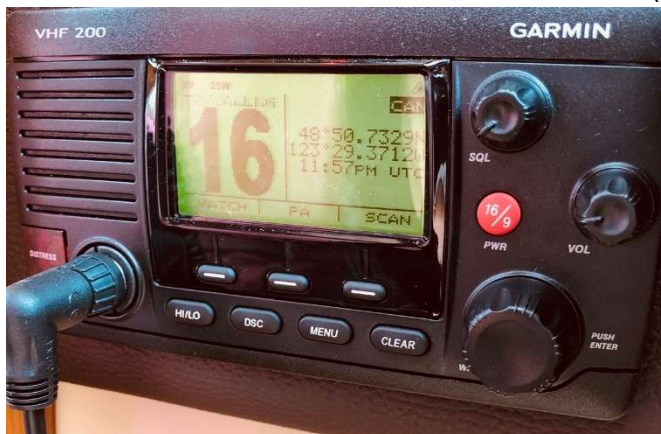
-Garmin VHF200 VHF radio with DSC button (A3). Serviceable.

- A3, register vessel for DSC (Digital Selective Calling) on cockpit VHF radio if not already completed. Complete an MMSI application form available from Industry Canada. Contact the Industry Canada District Office nearest you for more information.
- DO NOT TEST this Distress Alerting feature, there is no test feature, and in fact it is an offence under both the Canada Shipping Act and the Radio communication Act to send a false distress message.

- A3**, as noted on page 38 of the report, the vessel’s cockpit VHF radio DSC function should be registered with Industry Canada. Complete an MMSI application form available from Industry Canada. Contact the Industry Canada District Office nearest you for more information.

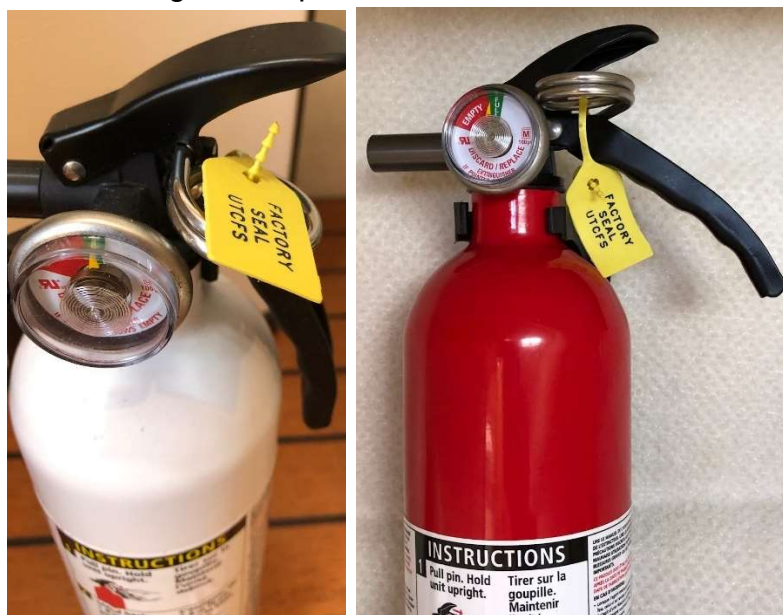
- Two (2) fire extinguishers onboard, one in on a shelf in the master berth and one on the floor in the quarter berth. Both were sealed with tags from the factory indicating neither had ever been used. Both are fully charged into the green area on gauges but no current annual inspection tags were observed, (A3). The white fire extinguisher is a 'K' type (Kitchen) and should be mounted in or within easy access of the galley. The red extinguisher is an 'ABC' type, multipurpose extinguisher and should be easily accessible near the engine compartment.

-A4, fire extinguishers have mounts attached but are not mounted. Both extinguishers should be mounted and should have inspection tags.

- A4**, as noted on page 40 of the report, fire extinguisher mounts should be properly fixed in place for fire extinguisher storage.
- A5**, as noted on page 40 of the report, no life jackets were sighted on board. An appropriate number of life jackets should be readily available on board prior to any voyage.

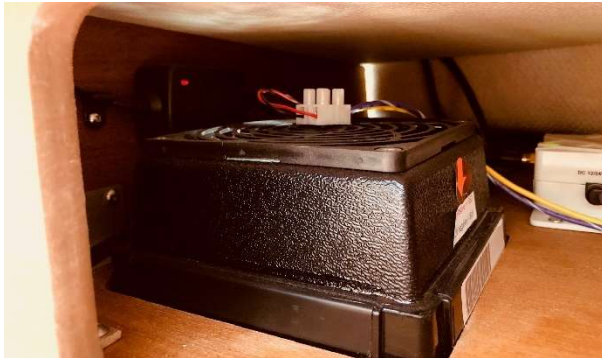
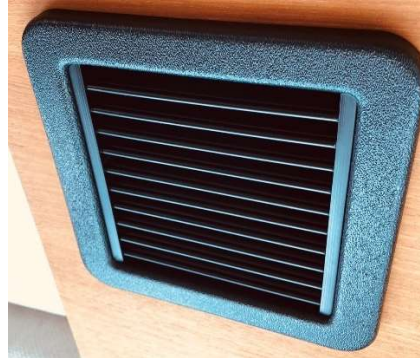
-Helm is equipped with two (2) electric heated defogging units for windshield. Starboard side shown below. Demonstrated.
