Report of Marine Survey

2017 Ranger Tug R-27

Scope of Survey

The surveyor attended aboard the 2017 Ranger Tug R-27, [REDACTED]', at the request [REDACTED] [REDACTED], beginning [REDACTED] and finishing on [REDACTED]. The Survey was requested to determine the condition prior to potential purchase, a Pre-Purchase Survey.

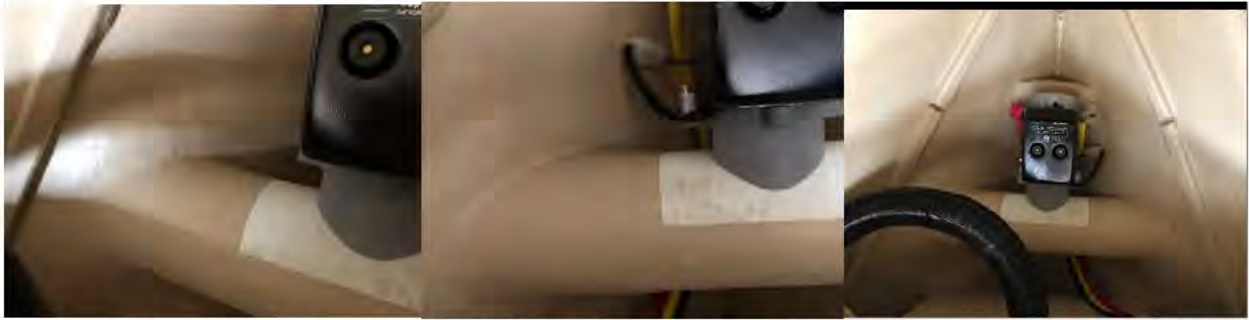
- Bilges were viewed in engine room and forward beneath the lockers in master stateroom.
- Bilges beneath the forward in-floor lockers are spotless and look to have never seen water.
- The forward bow thruster tube can also be viewed here and is also spotless with absolutely no indications of flawed joints to the hull.

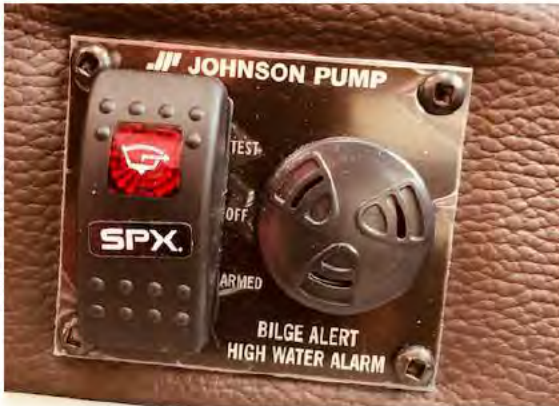
-The bilge pump powered up via the helm switch and the high-water level alarm is functional.

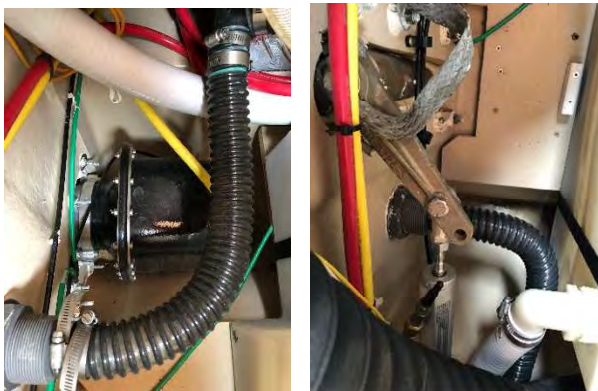
- The stern thruster mount is intact with no leaks and appears as new.
- The rudder was checked for leakage, none was found, and for play when the vessel was on the service trailer. Play was minimal.
- Rudder actuator was viewed during sea trail and is serviceable.
- Note the grounding strap, green grounding conductors and stainless steel double clamps.

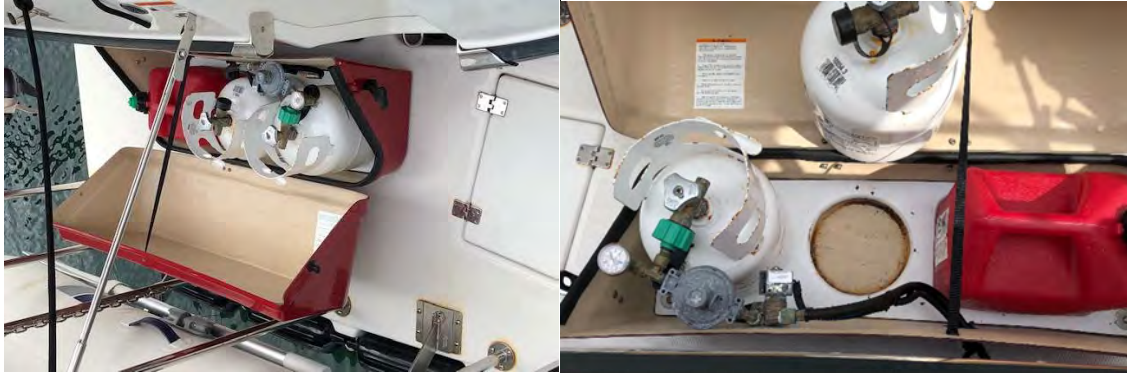
- Fixed white gelcoat finished platform.
- Has three stern fenders permanently attached horizontally across the stern edge**.
- Factory optional stern rails on platform.
- Integral 5 step concealed swim ladder**.
- Propane and tender fuel locker. Propane tanks are to be fixed into place. The base of the locker has a plate with cut-outs to match the base of the propane tank (see above) and when locker lid is closed, the tanks should not be able to move, however, code dictates tanks to be firmly fixed in place. Recommend installing a hold-down bar to hold tanks firmly in place (A1).
- Weaver davit installed for dinghy is removable with locking pins in plates.

- A1, recommend installing hold down bar on propane tanks.
- B1, recommend checking internal anodes, if any, on the engine raw water side of cooling system and replacing if necessary.

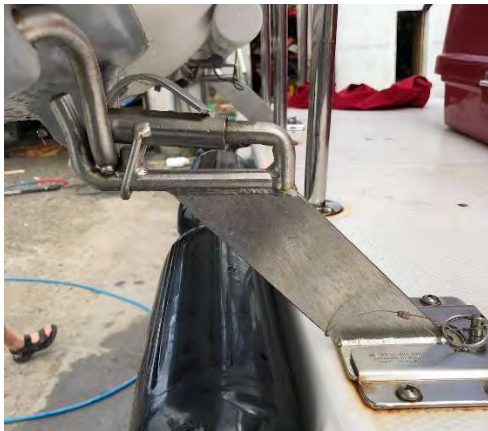
-Highfield Ultralight 260 (8.5') dinghy appears as new.

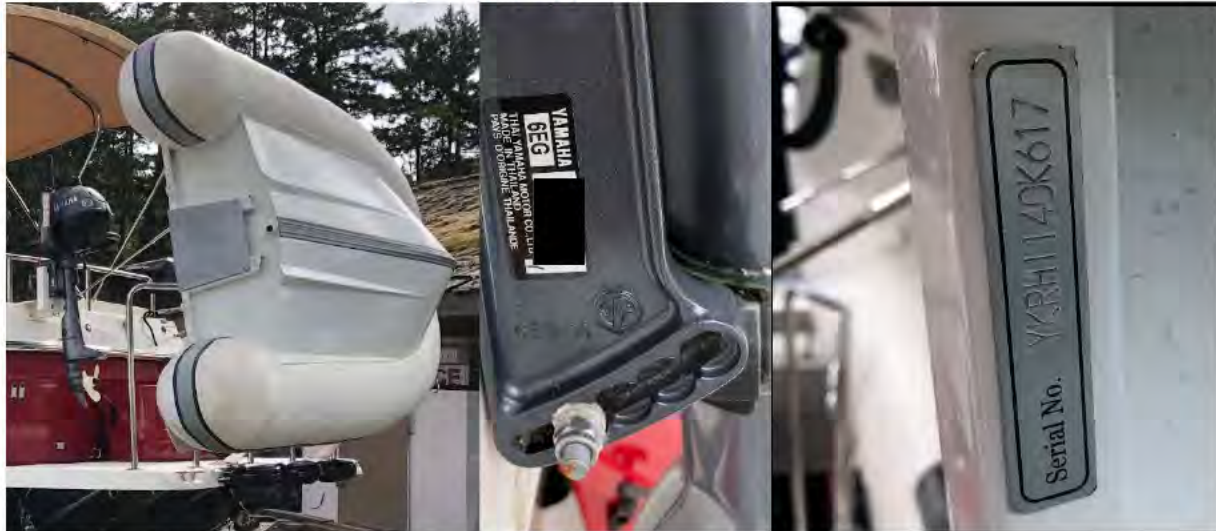
-Yamaha 2.5 Hp, four stroke liquid cooled O/B on stern storage mount appears as new. Engine was not fired but starter cord was pulled to confirm free engine movement and compression. Dinghy and motor serial numbers are shown above.

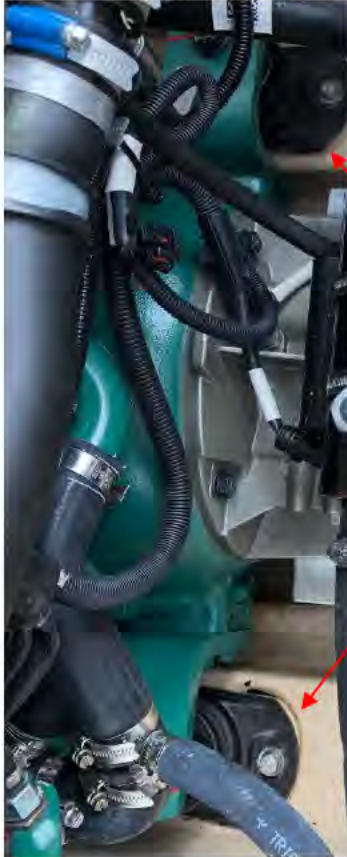
- Engine can be shut down at the helm with the keys and typically directly on the engine with 'Auxiliary Shut Down' button on the engine** (not sighted).
- Engine mounts are serviceable with no apparent wear or observed movement. Aft engine mounts can be viewed as shown in photo below.

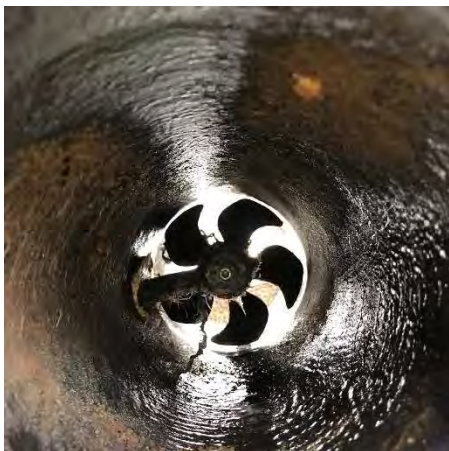
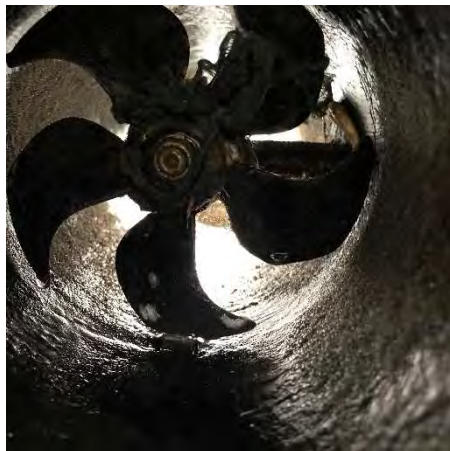
-Bow shown here.

-Thruster tubes and impellers have minor growth but are serviceable.

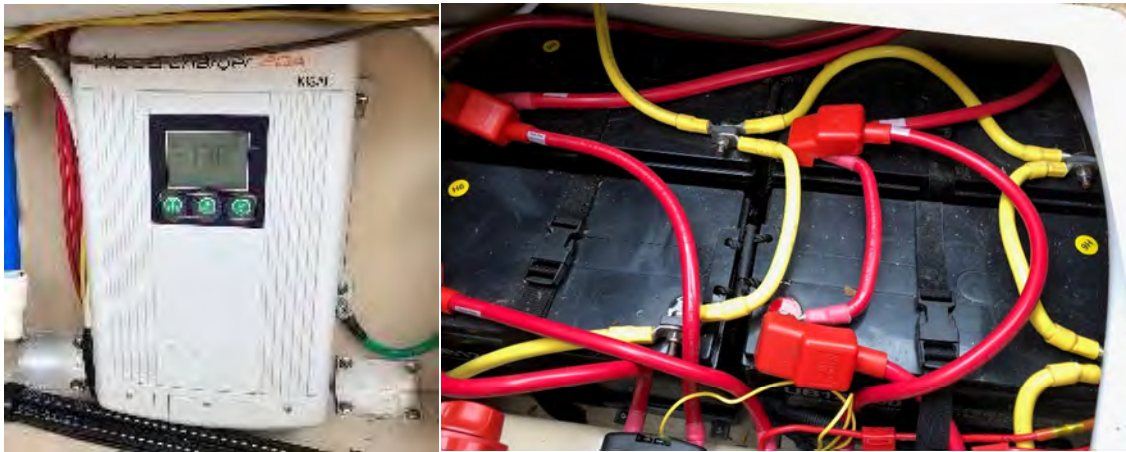
- Ships DC systems are 12V with 12V main engine starting circuits also.
- House batteries are three Universal Battery UB121100 Group 30H AGM (Absorbed Glass Mat) 110 Amp Hour each.
- Main engine starting battery is also a UB 121100 AGM battery.
- There is typically another 12V battery for the windlass but was not sighted. The windlass may be powered from the house batteries.
- Battery charger is 3 bank, 20 Amp Kisae with digital display.

- Charger display indicate proper operation. Display shows batteries at 13.8 Volts.
- Volvo ECV display indicates main engine is equipped with 12V alternator operating properly at +/- 14V.
- 12V wiring appeared to be well supported and secured, where sighted. Chafe gear was sighted at key friction points where viewable.
- 12 Volt outlets at the helm and in the cabin tested at 12.8 volts as did the two downrigger plugs on aft deck.
- The main DC breaker switches were installed in the main panel located at the helm. All breakers and switches were labelled with breaker size and switch function.
- DC is the left side of the panel with AC on the right.
- Toggle switch at top of DC panel section to read voltage from house battery 1, 2 or 3.

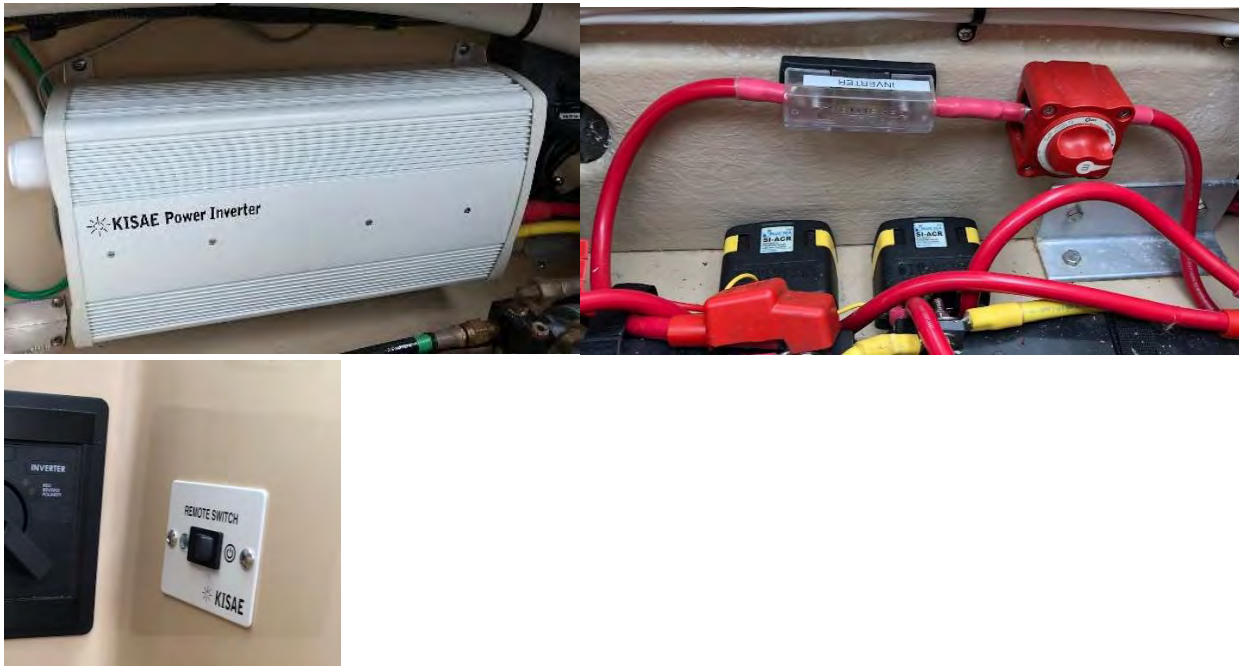
-Kisae SW 1220, true sine wave 2000 watt inverter demonstrated by powering microwave oven. Inverter connections are via rotary switch and inline fuse with activation switch at helm.

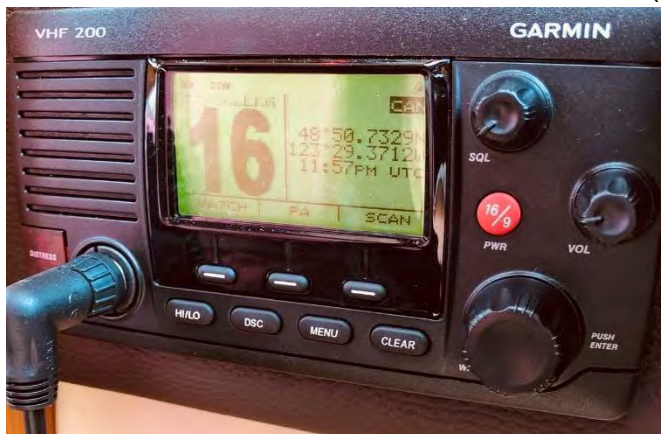
-Garmin VHF200 VHF radio with DSC button (A3). Serviceable.

-A3, register vessel for DSC (Digital Selective Calling) on cockpit VHF radio if not already completed. Complete an MMSI application form available from Industry Canada. Contact the Industry Canada District Office nearest you for more information.

- A3**, as noted on page 38 of the report, the vessel's cockpit VHF radio DSC function should be registered with Industry Canada. Complete an MMSI application form available from Industry Canada. Contact the Industry Canada District Office nearest you for more information.

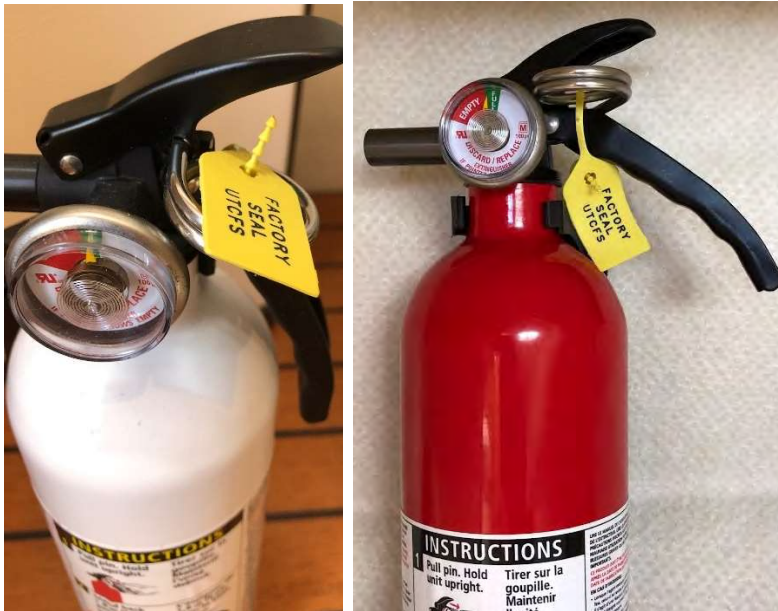
- Two (2) fire extinguishers onboard, one in on a shelf in the master berth and one on the floor in the quarter berth. Both were sealed with tags from the factory indicating neither had ever been used. Both are fully charged into the green area on gauges but no current annual inspection tags were observed, (A3). The white fire extinguisher is a 'K' type (Kitchen) and should be mounted in or within easy access of the galley. The red extinguisher is an 'ABC' type, multipurpose extinguisher and should be easily accessible near the engine compartment.

-A4, fire extinguishers have mounts attached but are not mounted. Both extinguishers should be mounted and should have inspection tags.

- A4**, as noted on page 40 of the report, fire extinguisher mounts should be properly fixed in place for fire extinguisher storage.
- A5**, as noted on page 40 of the report, no life jackets were sighted on board. An appropriate number of life jackets should be readily available on board prior to any voyage.
